1. The need for precise cleaning in the wafer shaping process

2. Sawed & Lapped wafer cleaning test

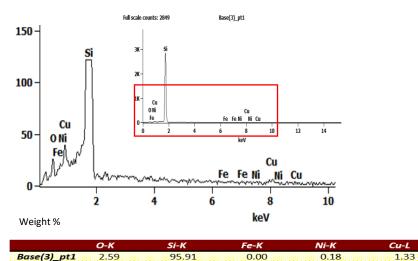
\triangle Before cleaning: Cu and Ni peaks are measured (A large amount of foreign matter accumulation is confirmed between the surface gaps on the image)

(Microscope image) 4K -3K-2K -1K-Cu Ni Cu Fe Fe Ni Ni Cu Fe 10 12 14 8 keV Weight % Si-K Fe-K Ni-K Cu-L 0.00 0.00 Base(4)_pt1 100.00 0.00
